PARKS & NATURAL  
RESOURCE DIVISION

LAND AND WATER  
PROGRAM

CROOKED LAKE

# MANAGING THE HEALTH OF THE NATURAL SYSTEMS

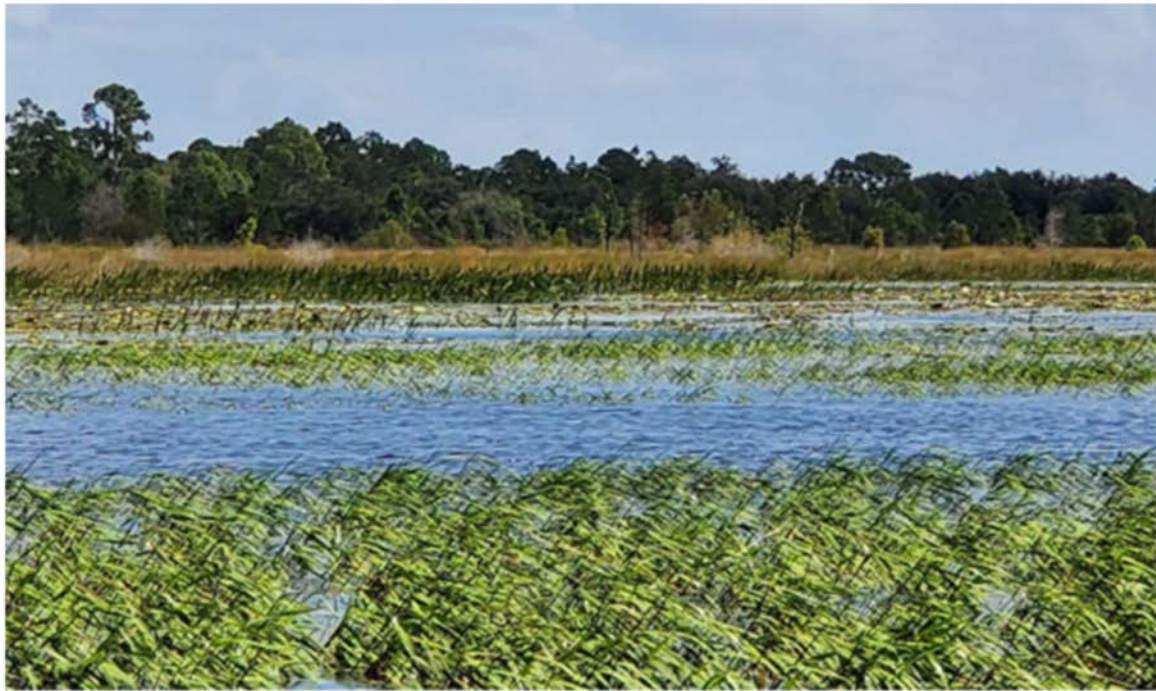
*Figure 2 Aerial photograph of the Crooked Lake showing typical coastal vegetation*

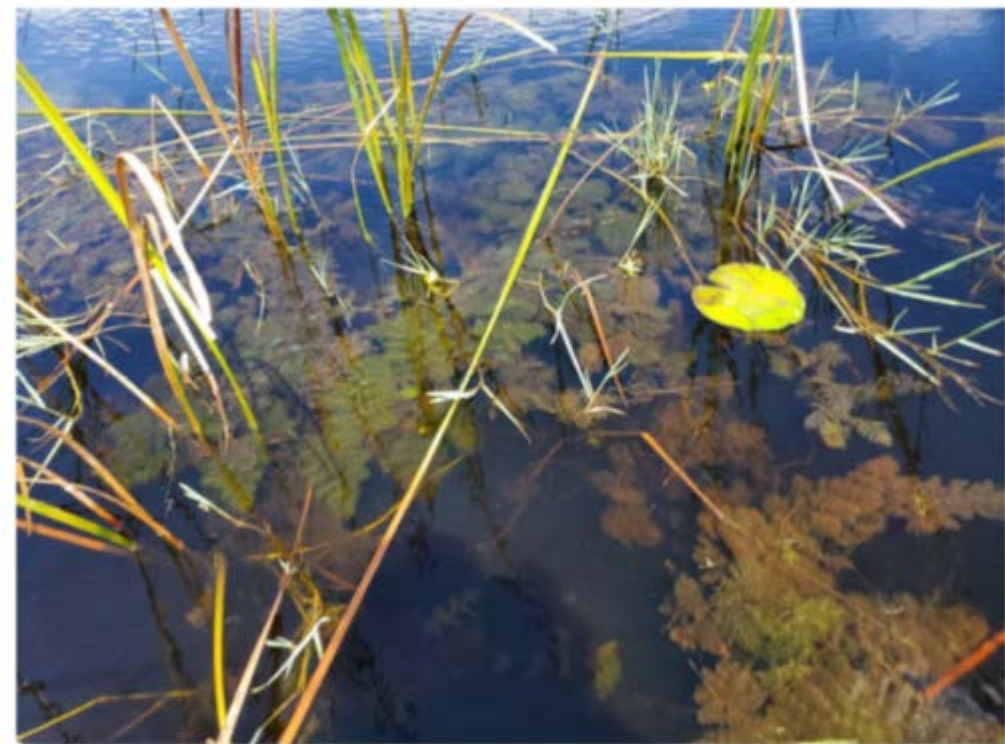
*Figure 3 Utricularia foliosa was the most common submerged vegetation species on Crooked Lake*

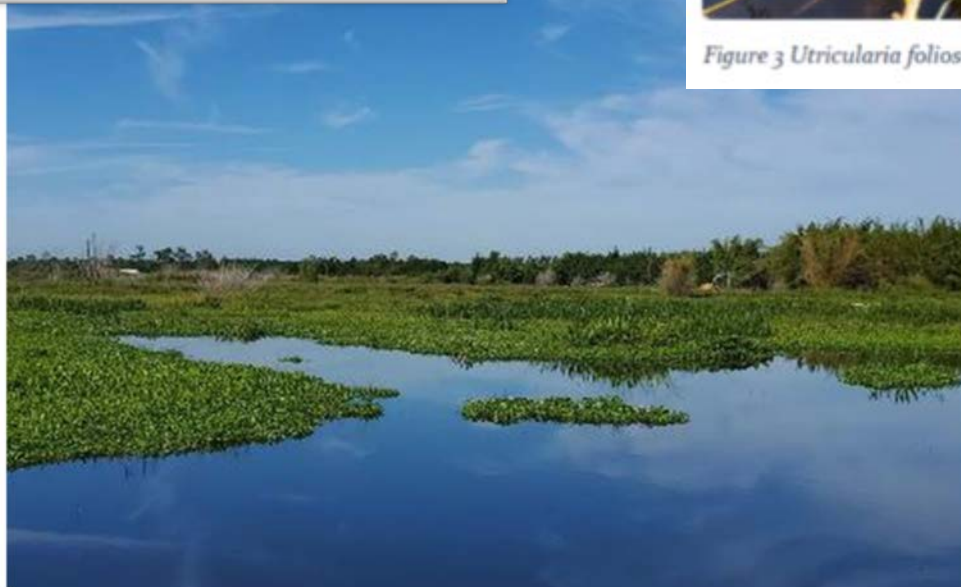
Turbidity (NTU)

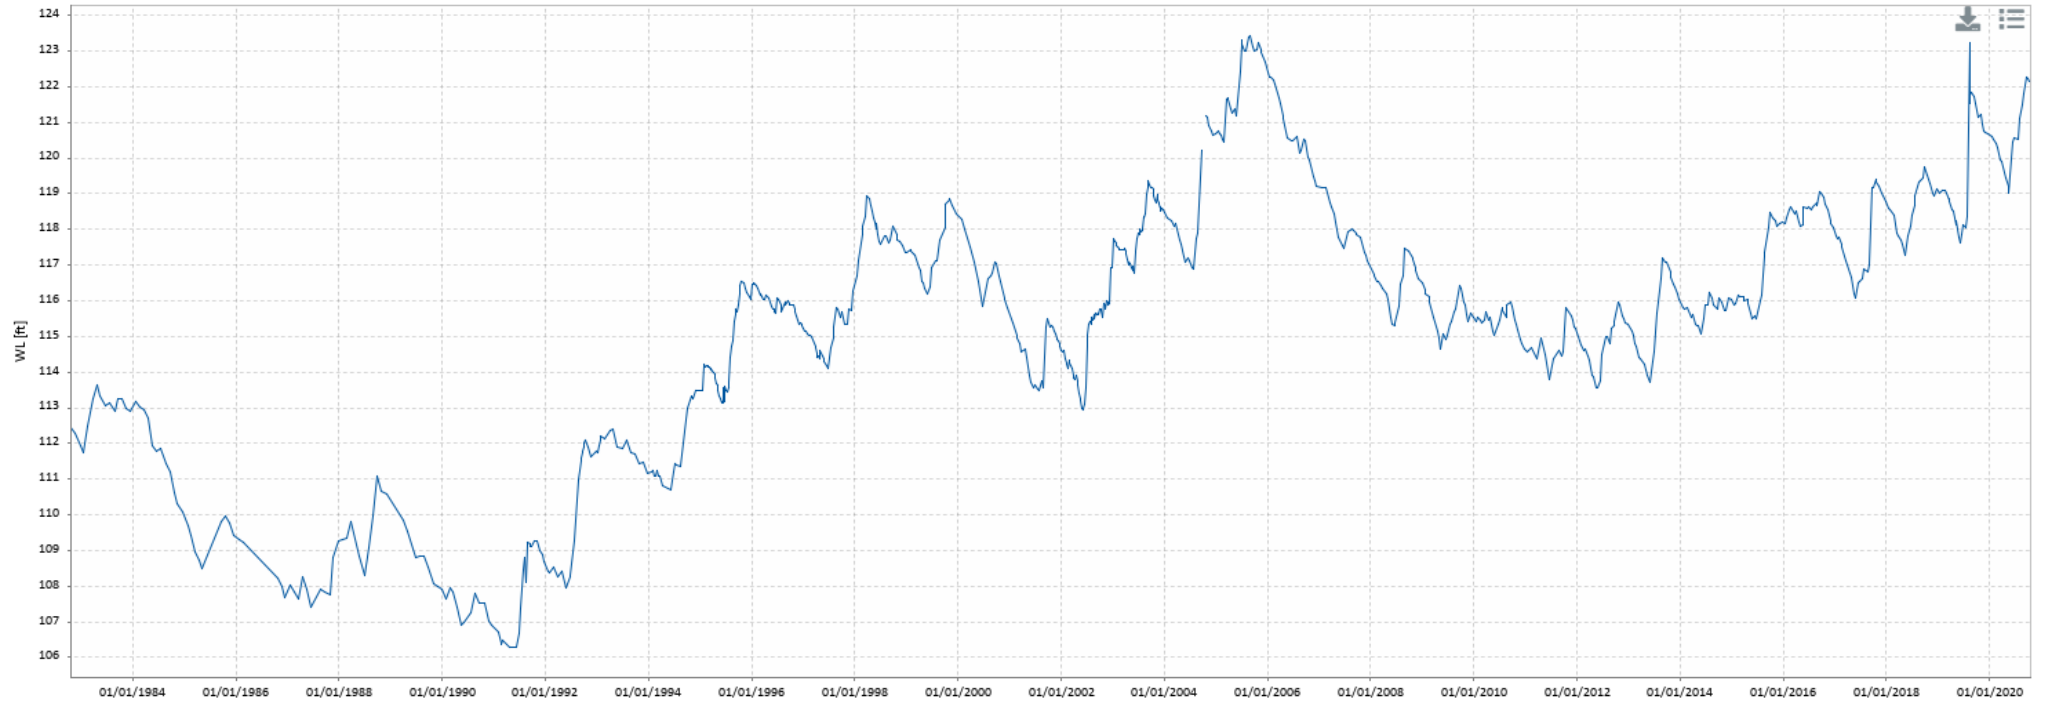
Water elevation

— Crooked Lake nr Babson Park / WL / 402.WL\_NGVD29\_District\_Manual.E
